# **LAUNCH AND LANDING**

**STS-103**  
**FLIGHT READINESS REVIEW**

**November 19, 1999**

**Ground Operations**

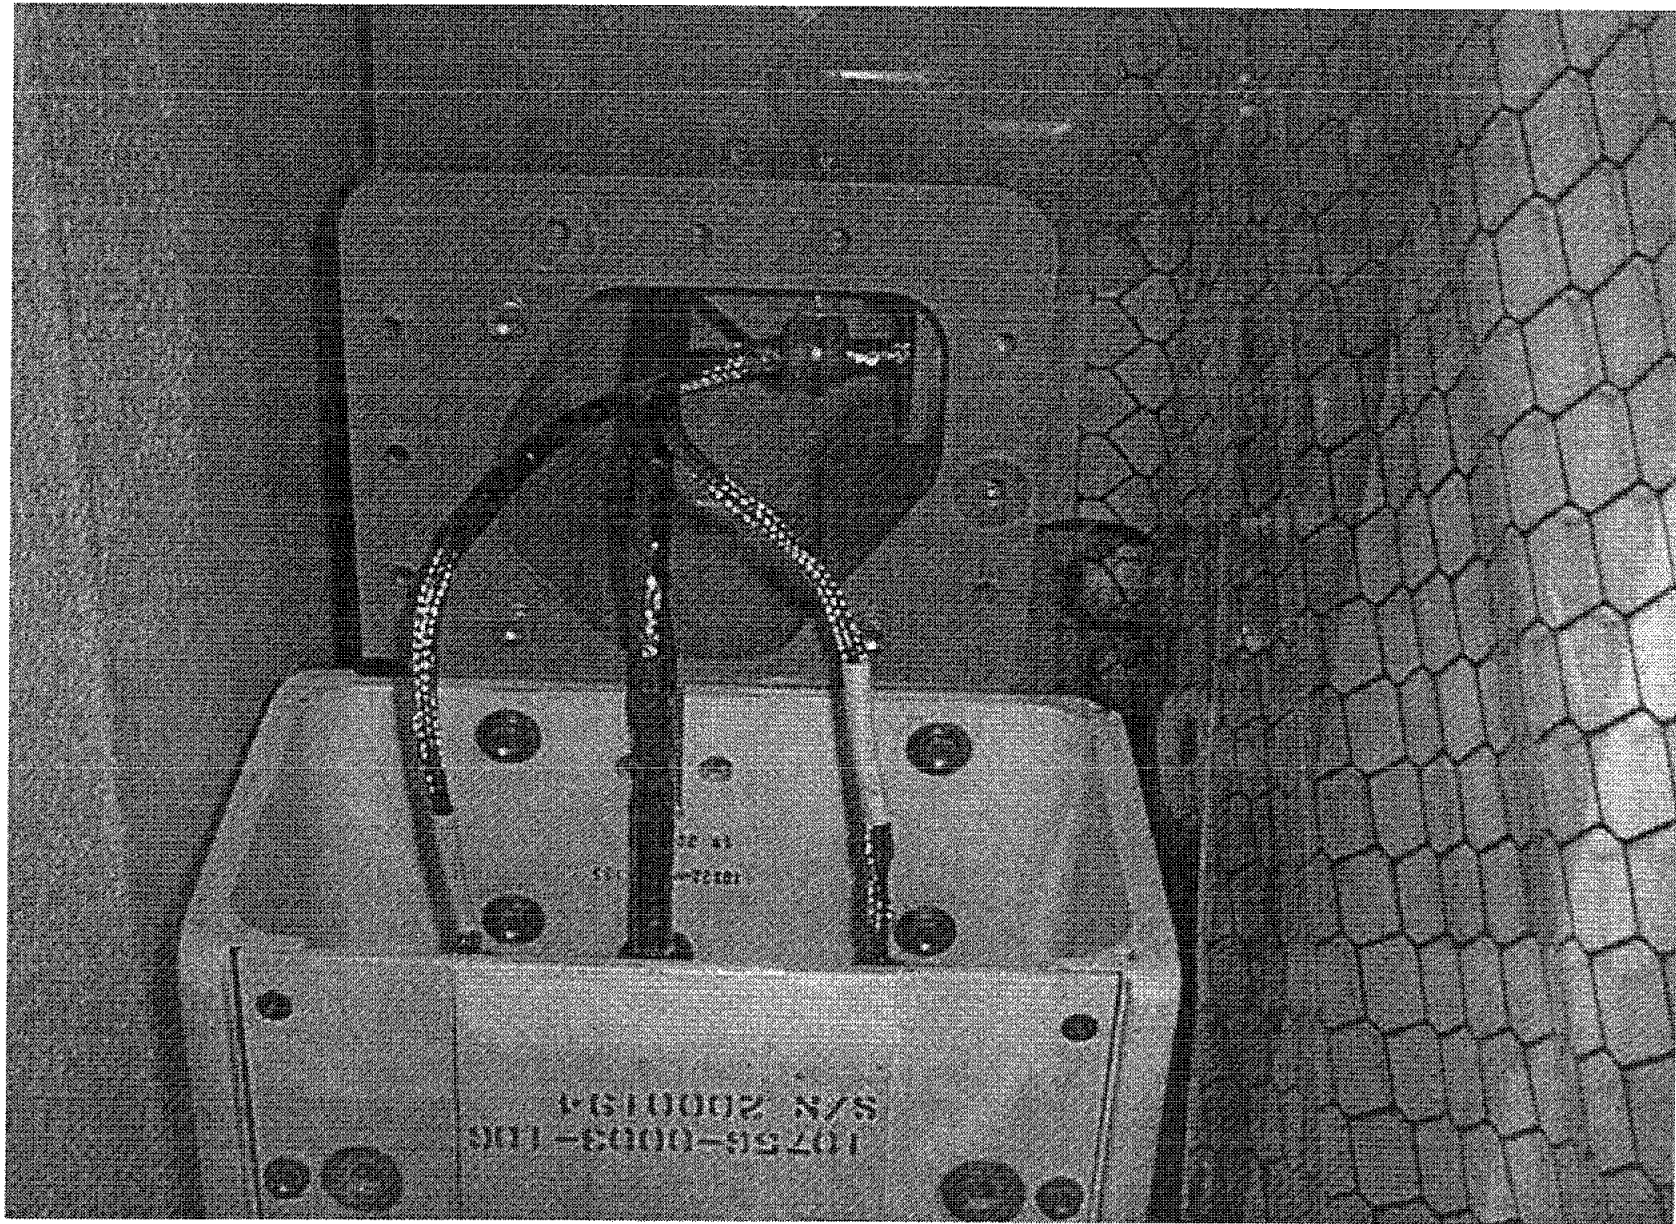
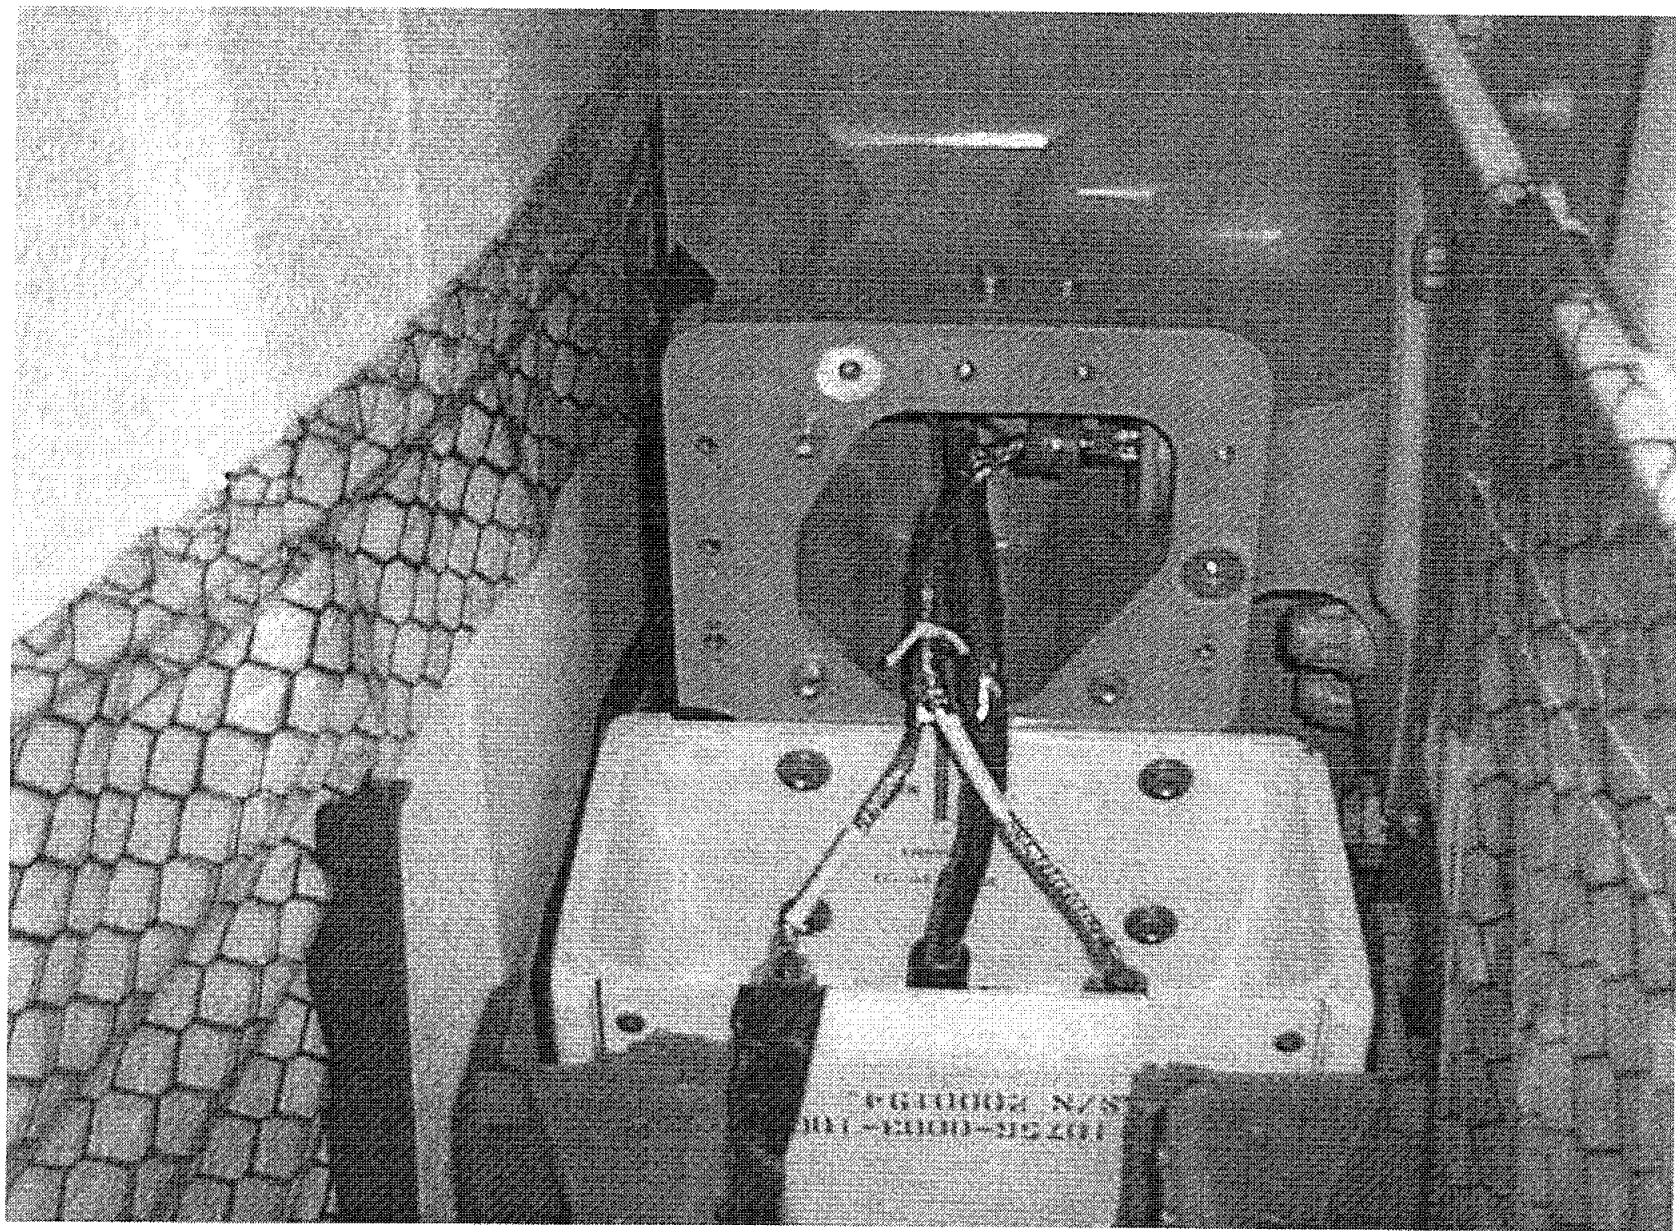
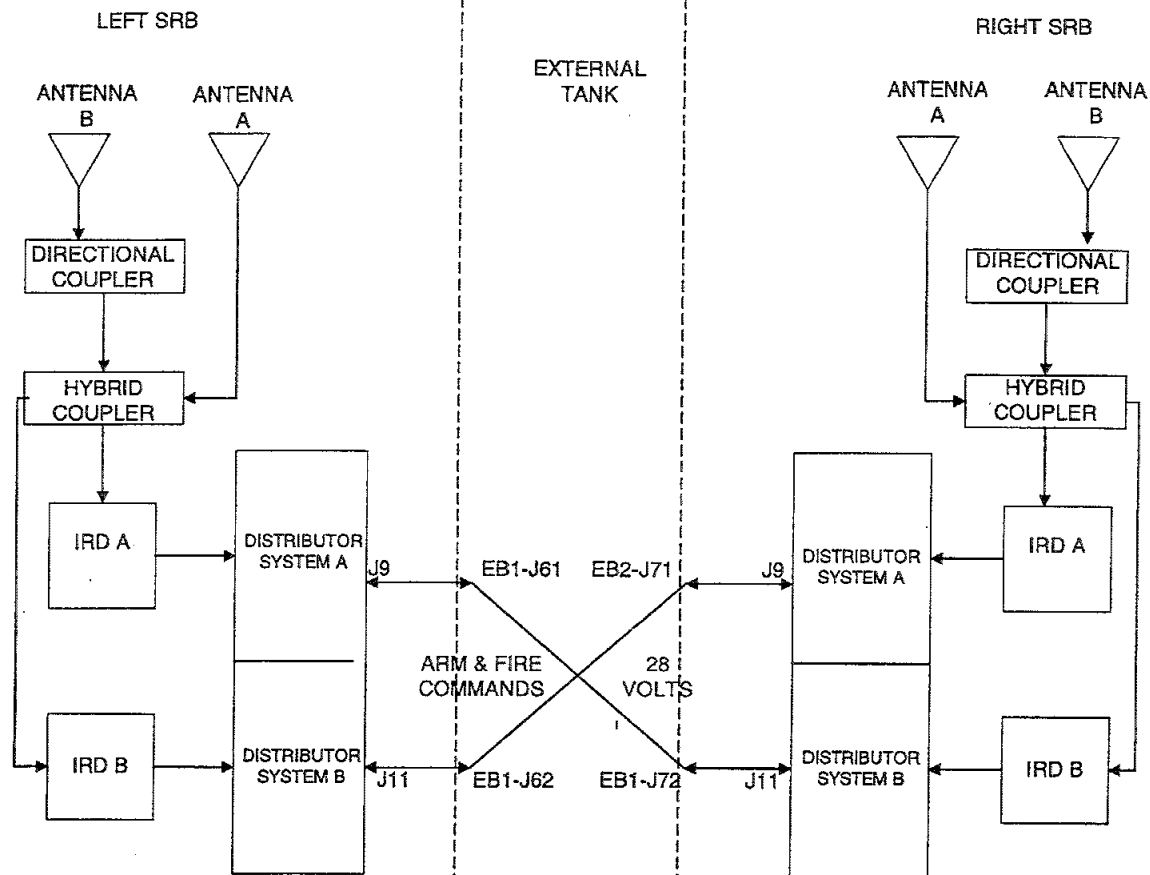
- Title: ET/SRB Cross Strap Cable Failure
- Observation
  - During the Range Safety Test the Left-Hand System A Arm command did not arm Right-Hand System B
  - This is the first time the RSS System is checked out in a closeout for flight configuration. This task has always been a constraint to rollout to the pad
- Concerns
  - Loss of Range Safety System Redundancy

- Title: ET/SRB Cross Strap Cable Failure
- Actions Taken
  - The remained of the RSS testing was completed successfully
  - Troubleshooting was performed to isolate the problem
    - Continuity/Isolation test was done on the LH A to RH B cable
      - Short identified in the Left/Right Hand crossover cable, and return line
    - During Right-Hand Fairing Cover removal, crushed cable identified between fairing cover, fwd attach point sealing surfaces
  - The replacement cable was retested in the VAB
    - Procedure was changed to restrained cables using Kapton Tape and Tie Cord to eliminate cable pinching

- Title: ET/SRB Cross Strap Cable Failure
- Open Actions
  - Evaluation of other areas was done and no additional inspections were required
- Risk Assessment
  - No change, the system has been returned to drawing configuration
- Summary
  - The RSS has been returned to drawing configuration and all OMRSD testing done
  - RSS is ready to support STS-103

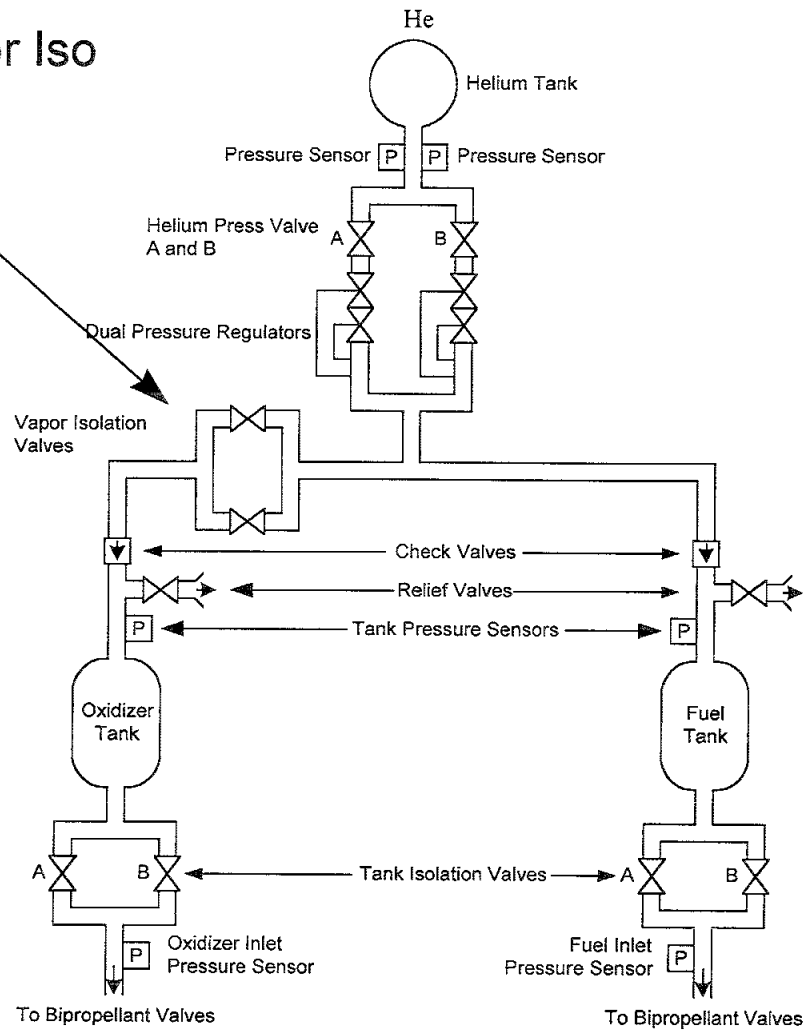
GO-BU-11

- Title: ROMS Vapor Iso Valve Indicated OPEN When Commanded CLOSE (LV-506) (PR-UA-3-0150)
- Observations
  - During the OMS/RCS He system checkout LV-506 was commanded CLOSE using LPS, the indication showed OPEN
  - The valve was confirmed to be CLOSE by gas flow
  - A BITE TEST 4 verified the CLOSE command was sent and the OPEN command was OFF
- Actions Taken
  - The valve was cycled 10 times and all indications were nominal
  - A wiggle test was performed in accessible areas from the Pod I/F to the Avionics Bay 6 which did not recreate the anomaly
  - A review of SCAN found no history of connector demate

- Title: ROMS Vapor Iso Valve Indicated OPEN When Commanded CLOSE (LV-506) (PR-UA-3-0150)
- Most probable Cause
  - Contamination on the Microswitch
- Risk Assessment
  - Low risk because of redundant flow path
- Flight Effect
  - None
    - The failure was indication only and the valve functioned correctly
    - If a false indication was to happen again, cycling the valve would most likely clear the indication
    - There is a redundant flow path through Vapor Isolation Valve LV-504

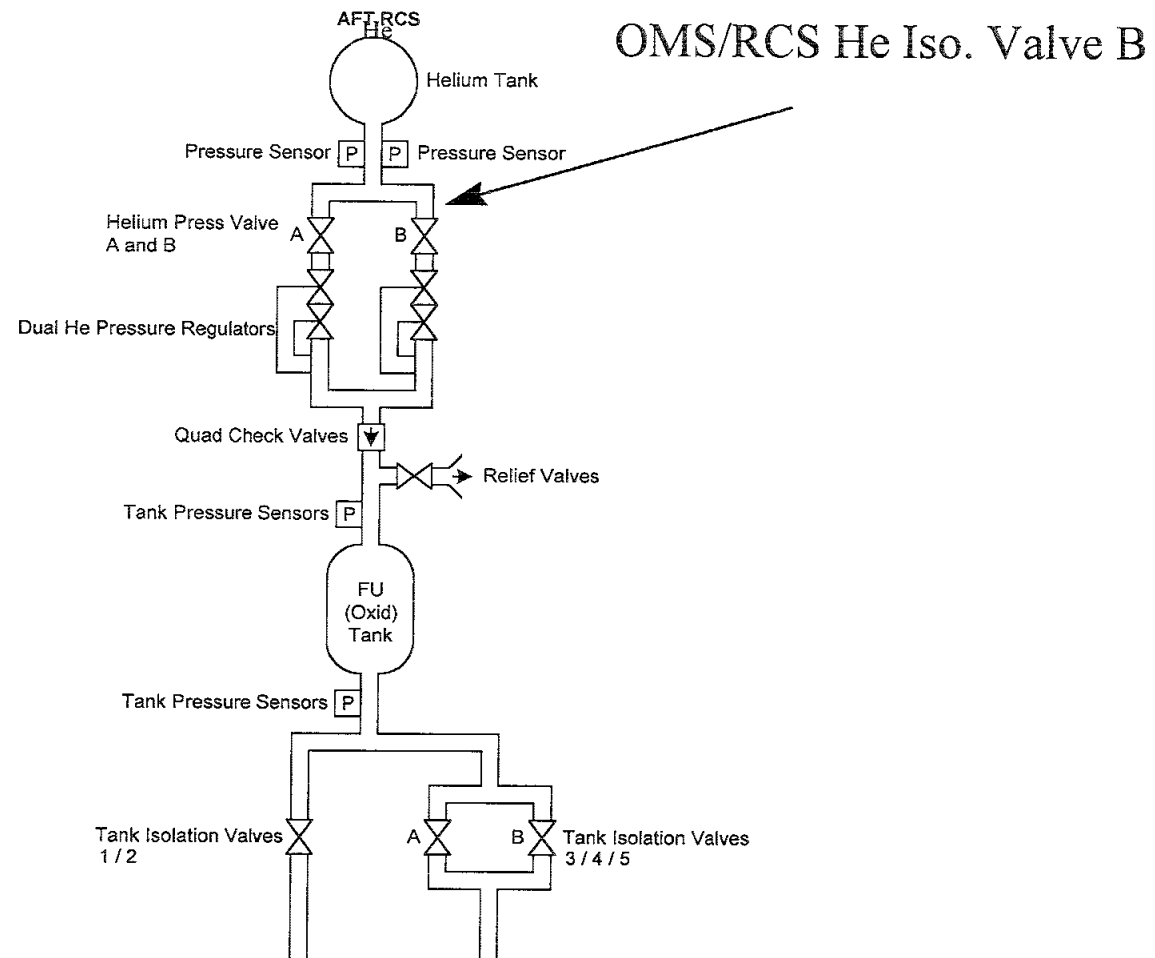
GO-BU-15

- Title: LRCS He Iso Valve B Indicated OPEN When Commanded CLOSE (LV-201) (PR-UA-3-0151)
- Prior Occurrence
  - There has been one prior occurrence of this event on STS-95 and that was also an unexplained anomaly (Ref. IPR-95V-0025)
    - The valve was confirmed to be closed by gas flow
- Most Probable Cause
  - Intermittent failure of the VPI Reed Switch

- Title: LRCS He Iso Valve B Indicated OPEN When Commanded CLOSE (LV-201) (PR-UA-3-0151)
- Risk Assessment
  - Low risk because of redundant flow path
- Flight Rationale
  - None
    - If a false indication was to happen again, cycling the valve would most likely clear the indication
    - There is a redundant flow path through Helium Isolation Valve LV-203

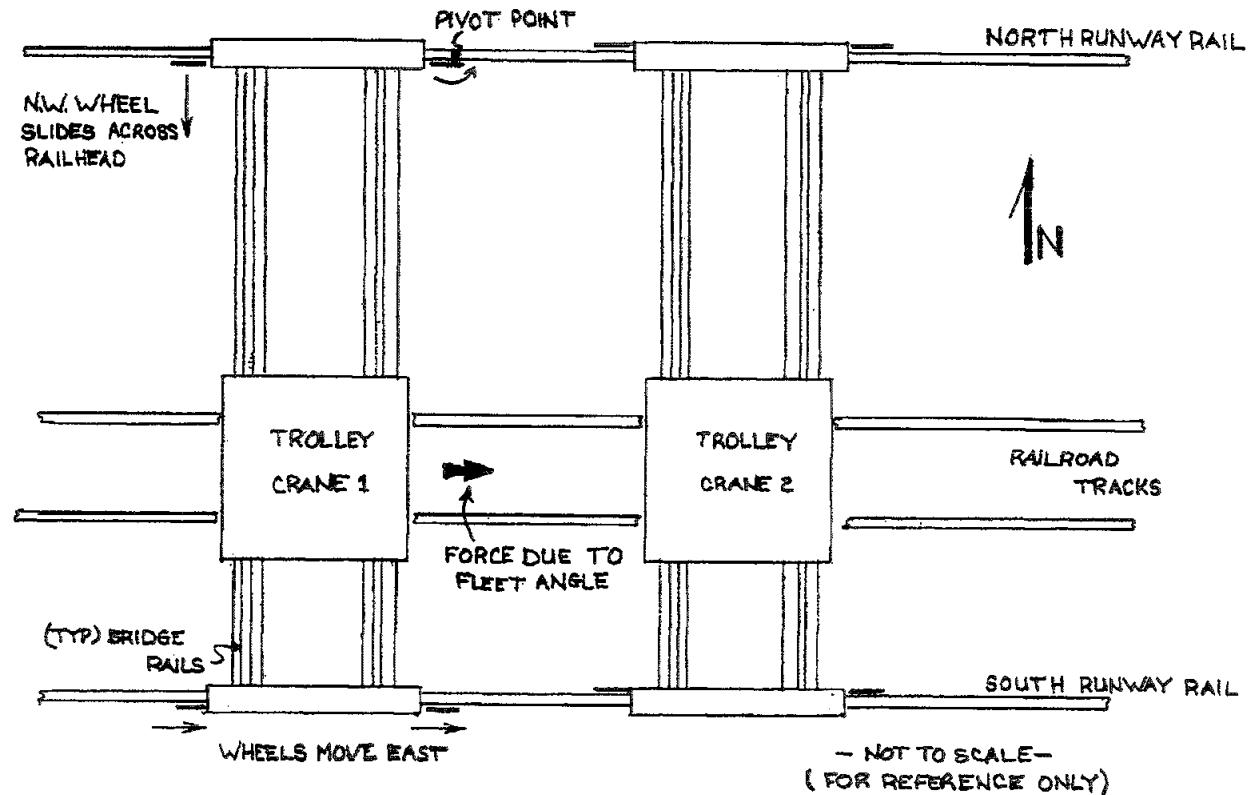
**UNEXPLAINED ANOMALY -  
RPSF NOISE INVESTIGATION  
(NORTH WEST WHEEL SLIDE ON CRANE 1)**

- Title: RPSF Noise Investigation (Cont'd)
- Most Probable Cause (Cont'd)
  - Most probable cause for the July 1st and 31st noises:
    - The north west wheel of crane # 1 moved south across the railhead due to forces induced by a significant fleet angle to the horizontal segment, wheel flange position, and the unsynchronized bridge drives
    - The original event was duplicated as close as possible on July 31st with the inert segment. As the segment was supported horizontally between the 200-ton cranes, a fleet angle of approximately three degrees was achieved by moving crane # 2 east. When both cranes were commanded to bridge east, the flange of the north east wheel of crane # 1 was binding against the north runway. This restricted movement of the north side of the crane # 1 bridge

- Title: RPSF Noise Investigation (Cont'd)
- Most Probable Cause (Cont'd)
  - Most probable cause for the July 1st and 31st noises (Cont'd)
    - The south side of the crane started to move as the bridge drives were commanded east. This caused the crane to start to pivot about the binding north east wheel with the north west wheel slipping across the railhead causing considerable noise. The fleet angle between the crane and load added a significant horizontal force component that added to skewing motion and resultant motion of the north west wheel
    - Supported by accelerometer data and video/audio recordings
